Farm Legacy Report for Example Landowner

This report gives information about past, present, and desired future land-use and management for the land owned by Example Landowner (Attachment 1).

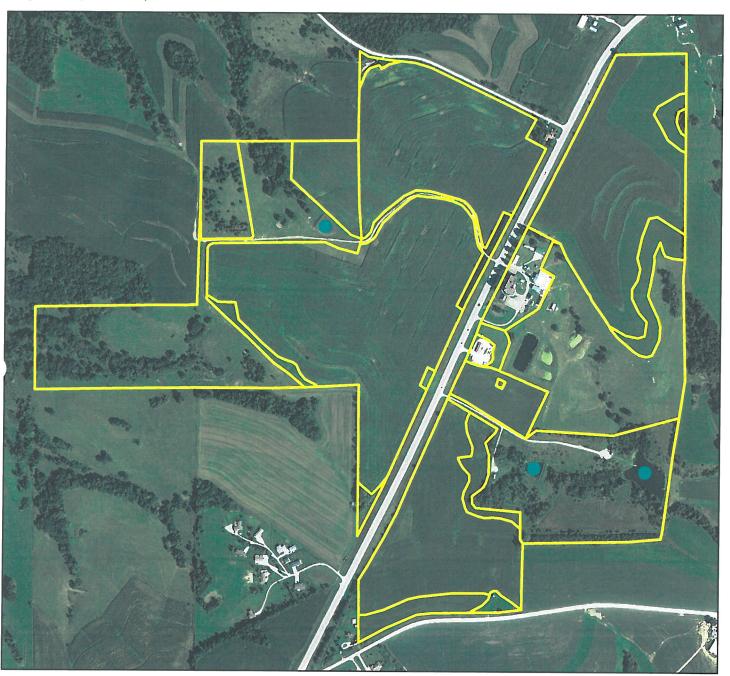
Pond Map

The locations of ponds are shown on **Attachment 14**. The landowner is expected to do some maintenance as needed to ensure the structural integrity of the sites. Periodic mowing may be required and trees should be kept from growing on the dam of the structures.
